# Manhole Inspection Summary

Manhole # S21AA\_053MH

Insp Date: **9/11/07 7:05 AM**

**Location** Address: **917 BRUCE ST**

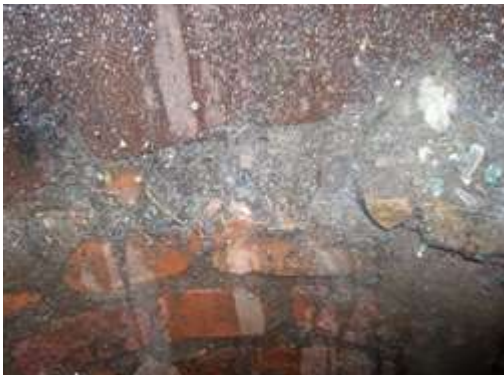
Defect 2

Condition: ☐ Sound ☐ Cracked ☐ Root Intrusion ☐ Loose Brick ☒ **Deteriorated**

DETERIORATED CORBEL

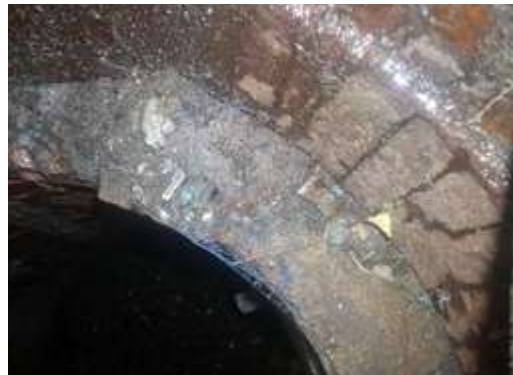
Defect 1

Offset: **3** (in.)

FRAME OFFSET

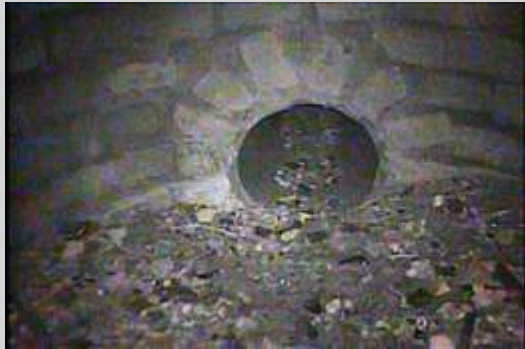
12 O'Clock Outflow

8 in. Circular Gravity Sewer  
Pipe Out @ 12 O'Clock

Deposits: ☐ None ☐ Mud ☐ Sludge ☒ **Debris** ☐ Grease

Silt Depth: **1** (in.) Deposits Extent: **Light**
